Manhole Inspection Summary

Manhole # S43O__005MH

Location Address: **rear 1500 thames st**

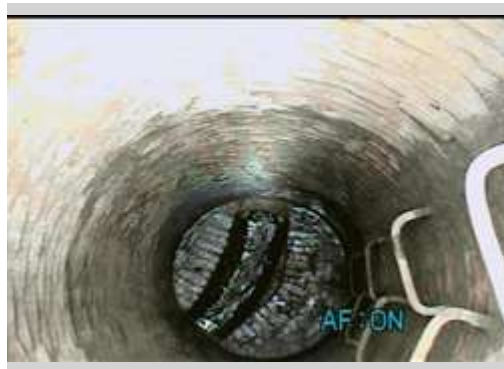
Top View

Top view & Steps

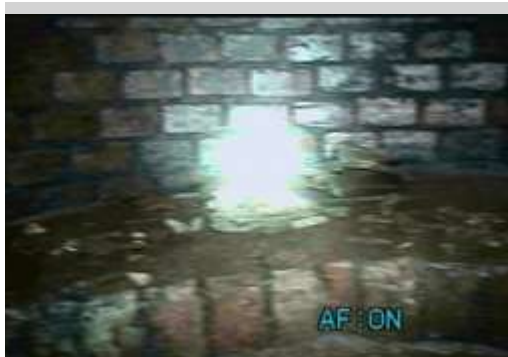
Misc

bench debris

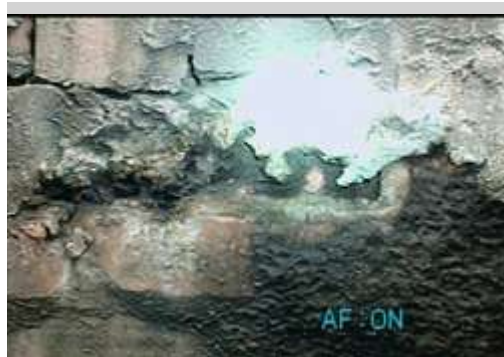
Defect 2

Infiltration: ☐ None ☐ Joint ☐ Cracks ☒ **Mortar** ☐ Roots ☐ Wall

infiltration from chimney mortar

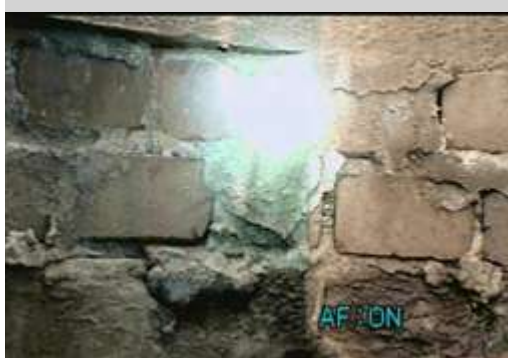
Defect 1

Condition: ☐ Sound ☐ Cracked ☐ Root Intrusion ☐ Loose Brick ☒ **Deteriorated**

chimney deteriorated

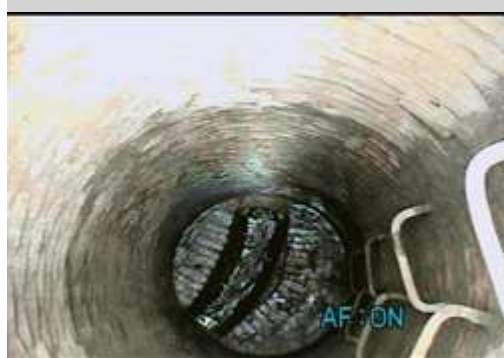
Defect 3

Count: **9** Missing: **0** ☒ **Corroded**

Top view & Steps

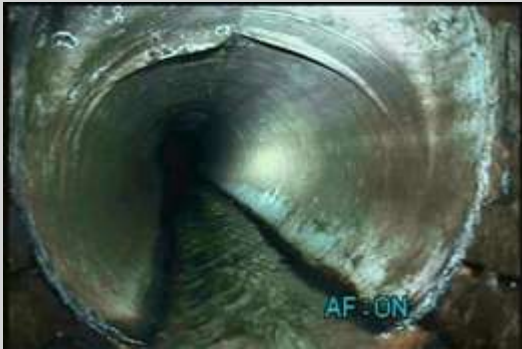
12 O'Clock Outflow

15 in. Circular Gravity Sewer
Pipe Out @ 12 O'Clock

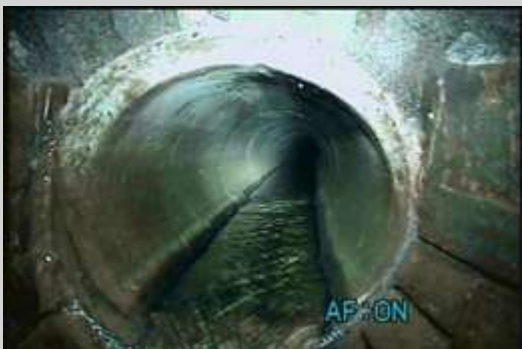
7 O'Clock Inflow

12 in. Circular Gravity Sewer
Pipe In @ 7 O'Clock
